**BURO HAPPOLD**  
**COPPERHOUSE SLUICE GATE**

Document Number: **C0395/006/DOC**

Document Title: **REPORT ON THE MECHANICAL SURVEY OF  
THE COPPERHOUSE SLUICE VERTICAL  
LIFT GATE**

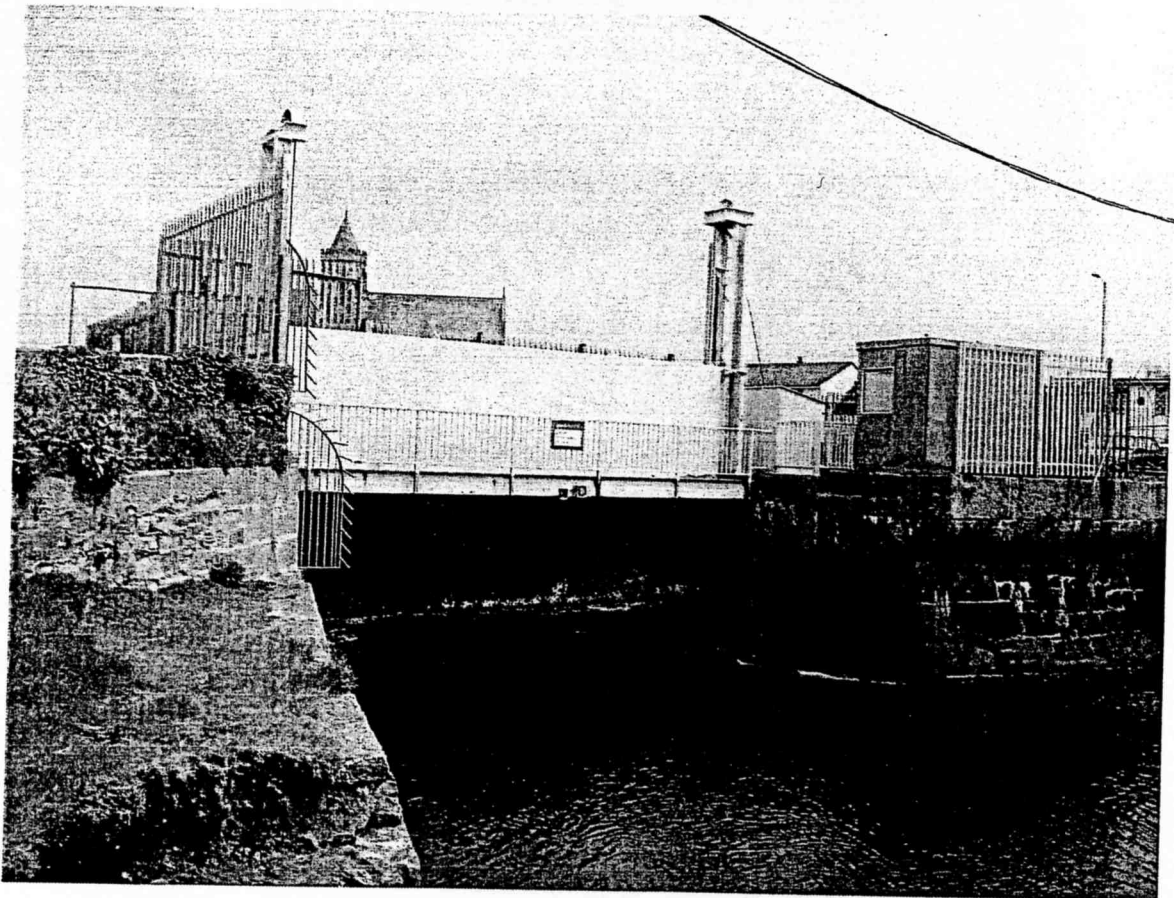
Photograph 1      General view of the gate; lifting frame superstructure, access footbridge, plant room and control cubicle of the vertical lift gate at Copperhouse Sluice
