BURO HAPPOLD
COPPERHOUSE SLUICE GATE

Document Number: **C0395/006/DOC**

Document Title: **REPORT ON THE MECHANICAL SURVEY OF
THE COPPERHOUSE SLUICE VERTICAL
LIFT GATE**

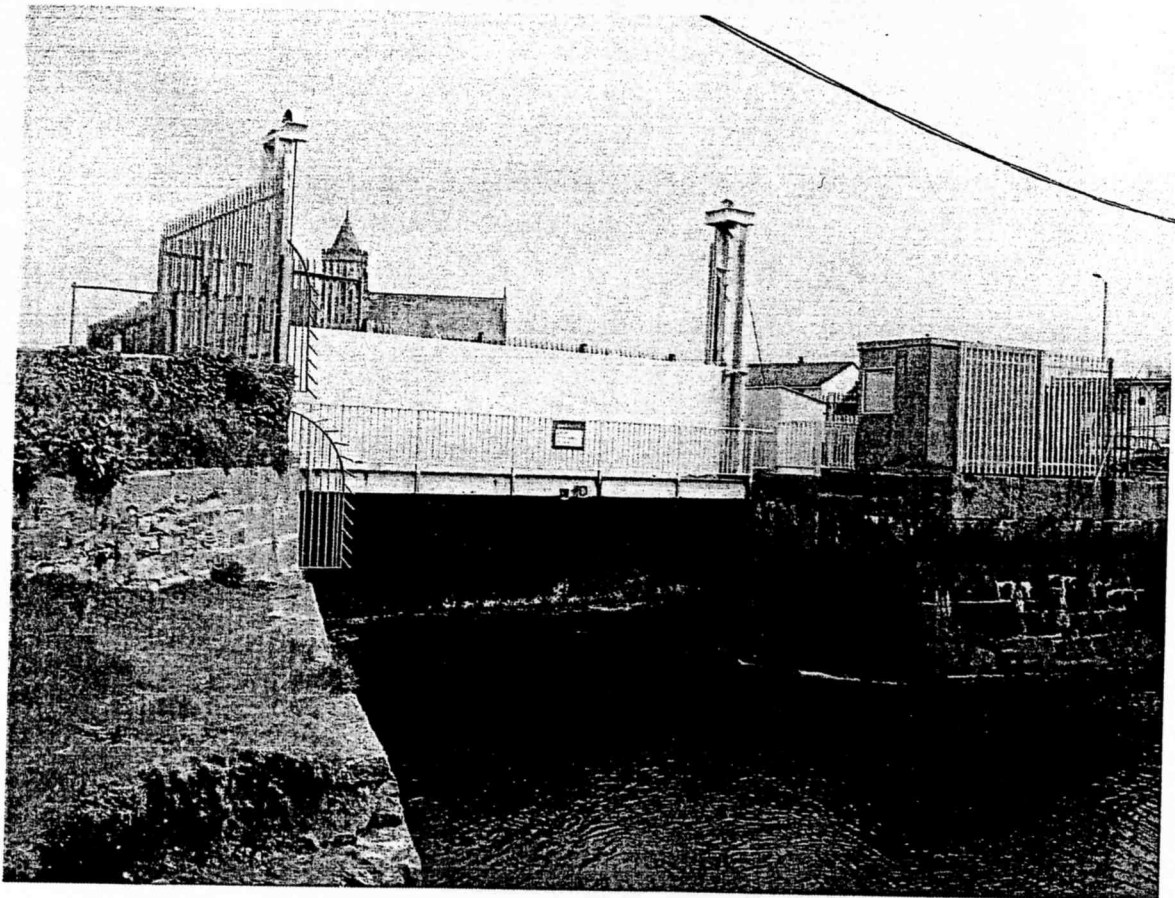
Photograph 1 General view of the gate; lifting frame superstructure, access footbridge, plant room and control cubicle of the vertical lift gate at Copperhouse Sluice
