HARVEY'S FOUNDRY, HAYLE. BLOCKED OPENING IN PATTERN SHOP.

Archaeological Evaluation

Cornwall Archaeological Unit

**Harvey's Foundry, Hayle.
Blocked Opening in Pattern Shop,
Archaeological Evaluation**

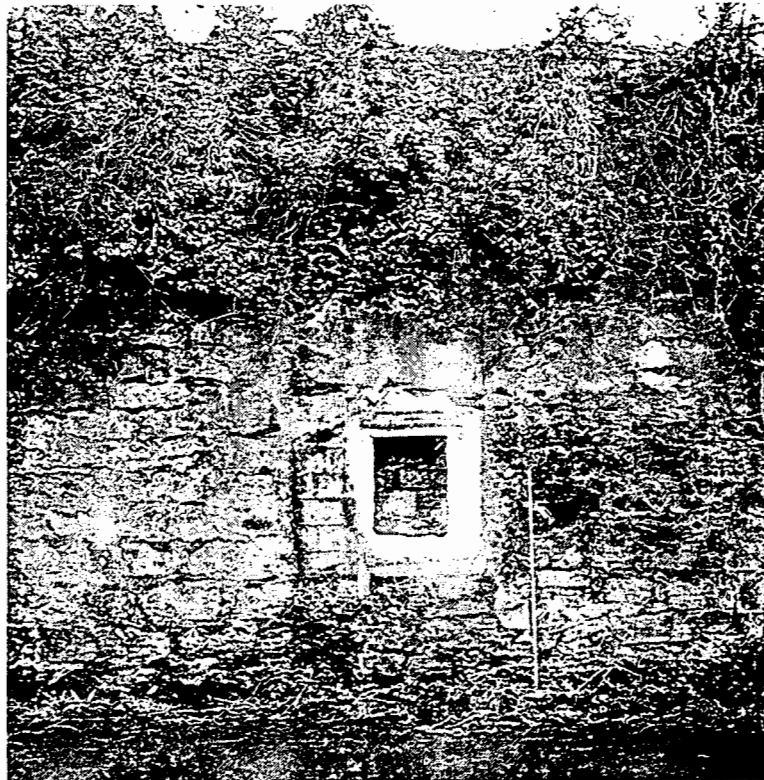
The blocked opening within the retaining wall.

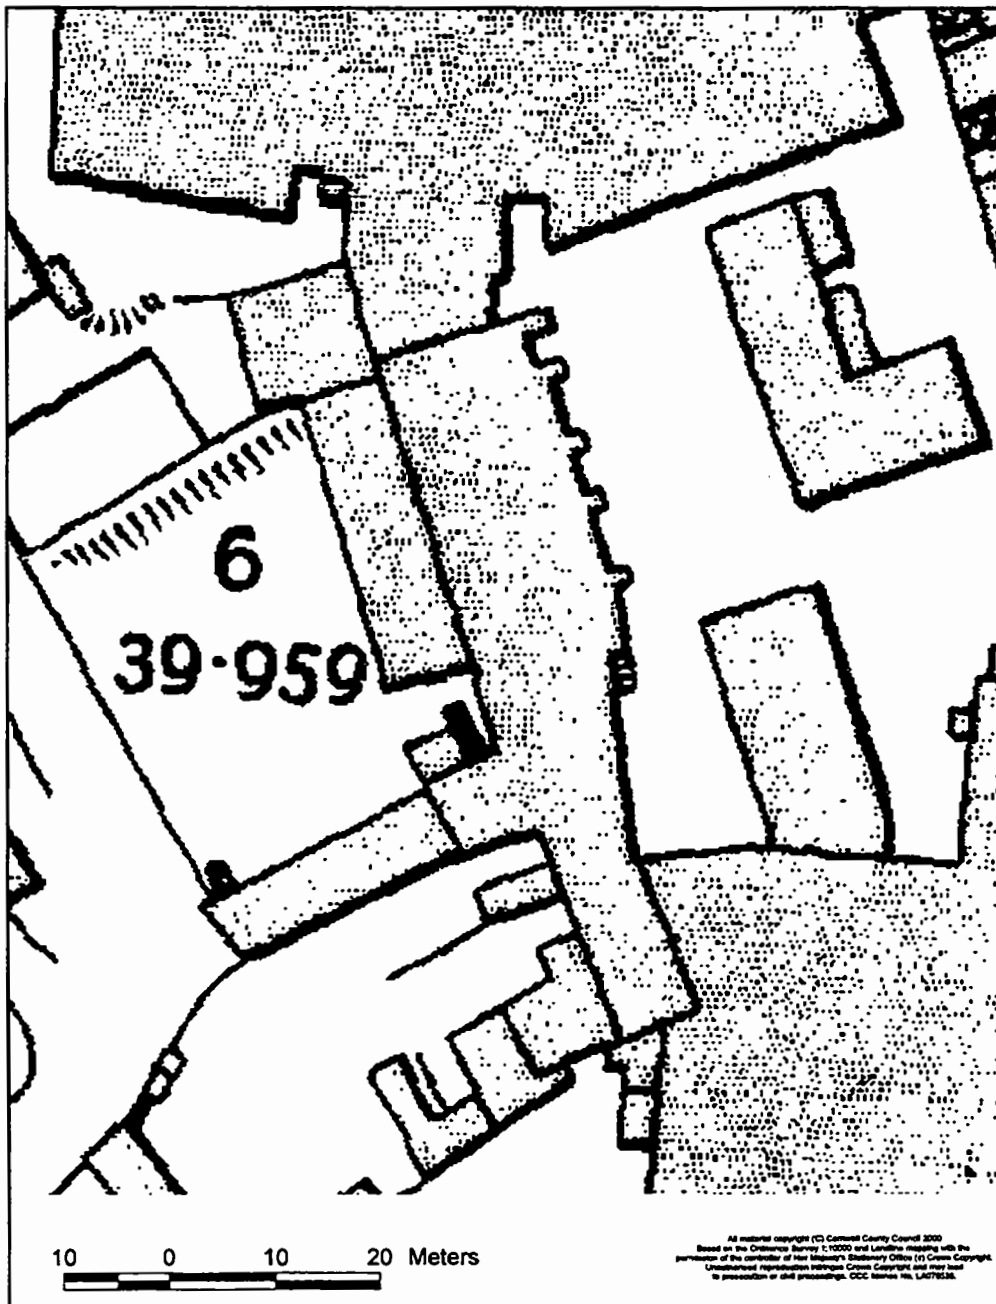
Fig. 4 Study area in 1907 showing Pattern Shop and Boring Mill (from OS map)

By 1907 (see Fig. 4), the yard to the west had been enclosed and by the 1930s (see Fig 4), the Boring Mill was no longer extant and the Pattern Shop was shown as an unroofed structure. The eastern wall of the Pattern Shop recorded in the 1930s no longer survives.
