# HARVEY'S FOUNDRY, HAYLE. BLOCKED OPENING IN PATTERN SHOP.

## Archaeological Evaluation

**Harvey's Foundry, Hayle.  
Blocked Opening in Pattern Shop,  
Archaeological Evaluation**

March 2002

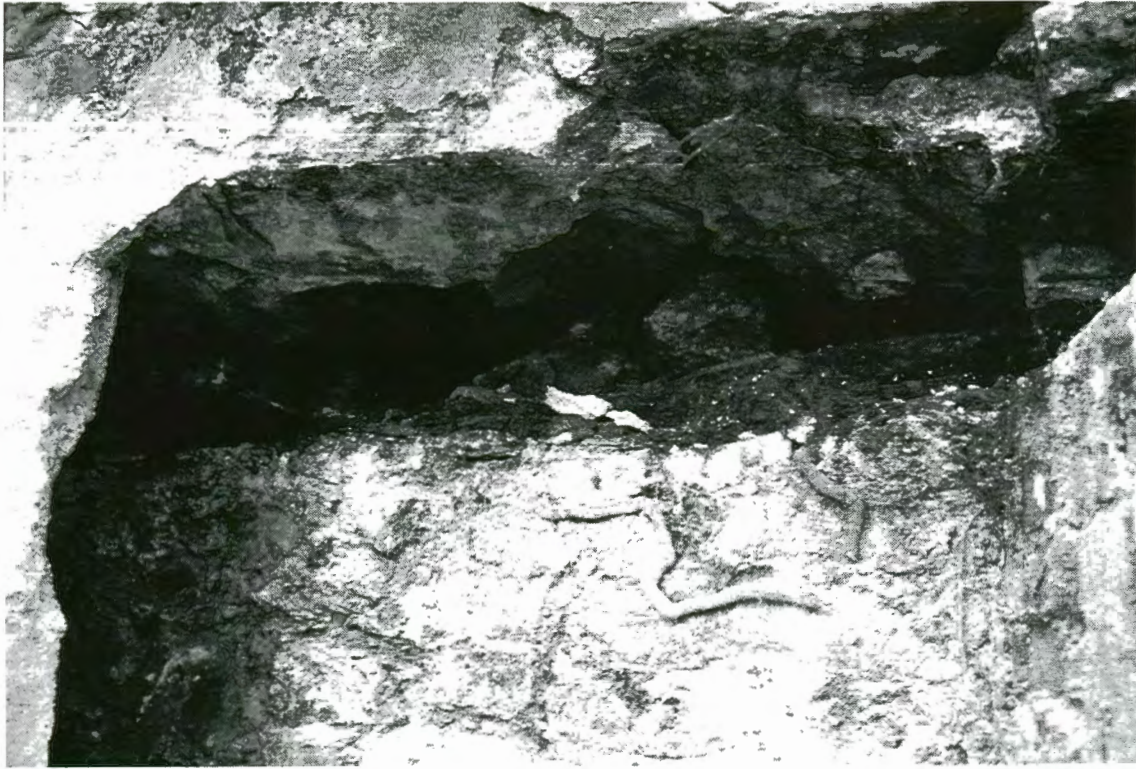
There was the remains of a wooden lintel directly above this inner wall (see Fig 7). The wall itself was partially removed and shown to be 0.6m thick.

*Fig. 6*      *Wooden lintel above inner blocking.*

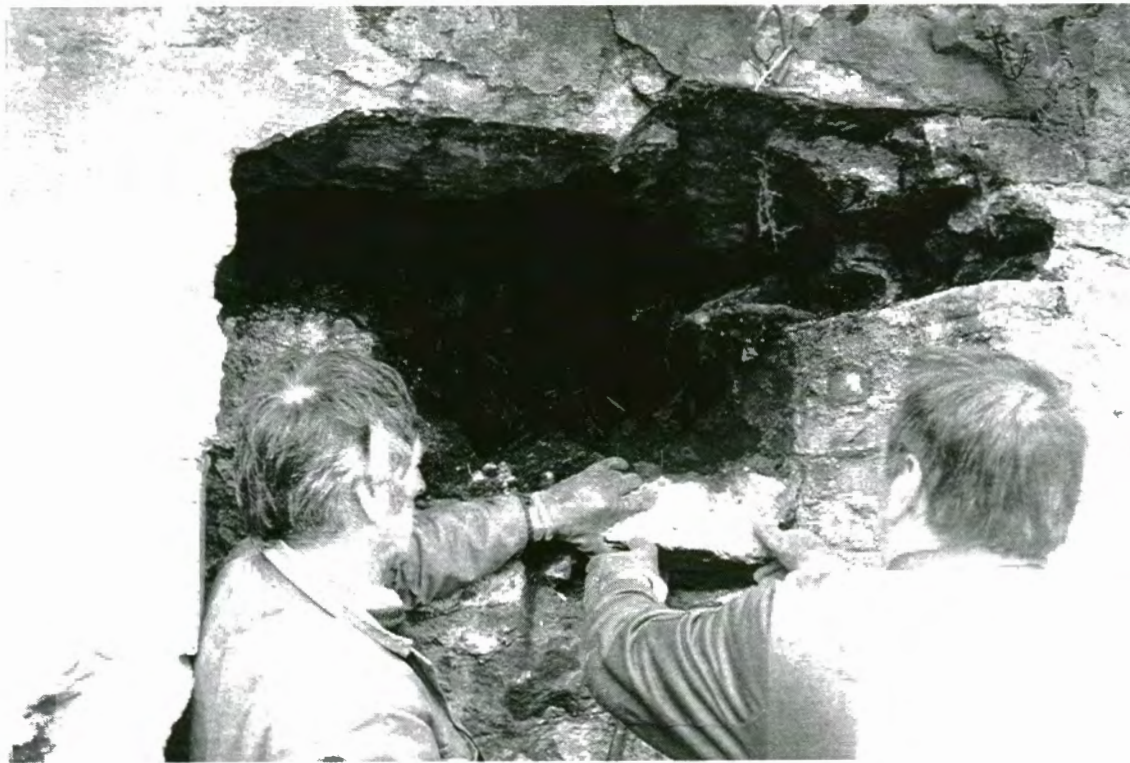
Behind the concrete walling, there was a further wall which had been built at a much earlier date to block the opening. It was constructed of square granite pieces, held together by a very earthy mortar.

Once a small amount of the inner wall had been removed, it was possible ascertain further details about the opening itself. The retaining wall was 1.1m thick at the top of the opening and the return of the wall was noted.

*Fig. 7*      *Removal of inner blocking in progress.*
